HOME REPORT

FLAT 0/3
52 MIDTON STREET
GLASGOW
G21 4RR

Energy Performance Certificate (EPC)

Single Survey

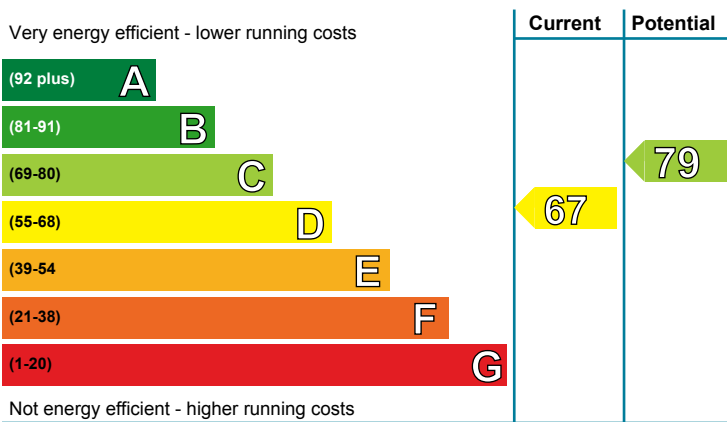
Energy Efficiency Rating

This graph shows the current efficiency of your home, taking into account both energy efficiency and fuel costs. The higher this rating, the lower your fuel bills are likely to be.

Your current rating is **band D (67)**. The average rating for EPCs in Scotland is **band D (61)**.

The potential rating shows the effect of undertaking all of the improvement measures listed within your recommendations report.
